**UNITED STATES ENVIRONMENTAL PROTECTION AGENCY**  
**REGION 10 Emergency Response Unit**  
**1200 Sixth Avenue, Suite 900**  
**Seattle, Washington 98101-3140**

**Final Removal Action Report for**  
**Black Butte Mine**  
**Cottage Grove, Oregon**

**July 20, 2008**

**Prepared by Kathy Parker, On-Scene Coordinator**  
**United States Environmental Protection Agency**

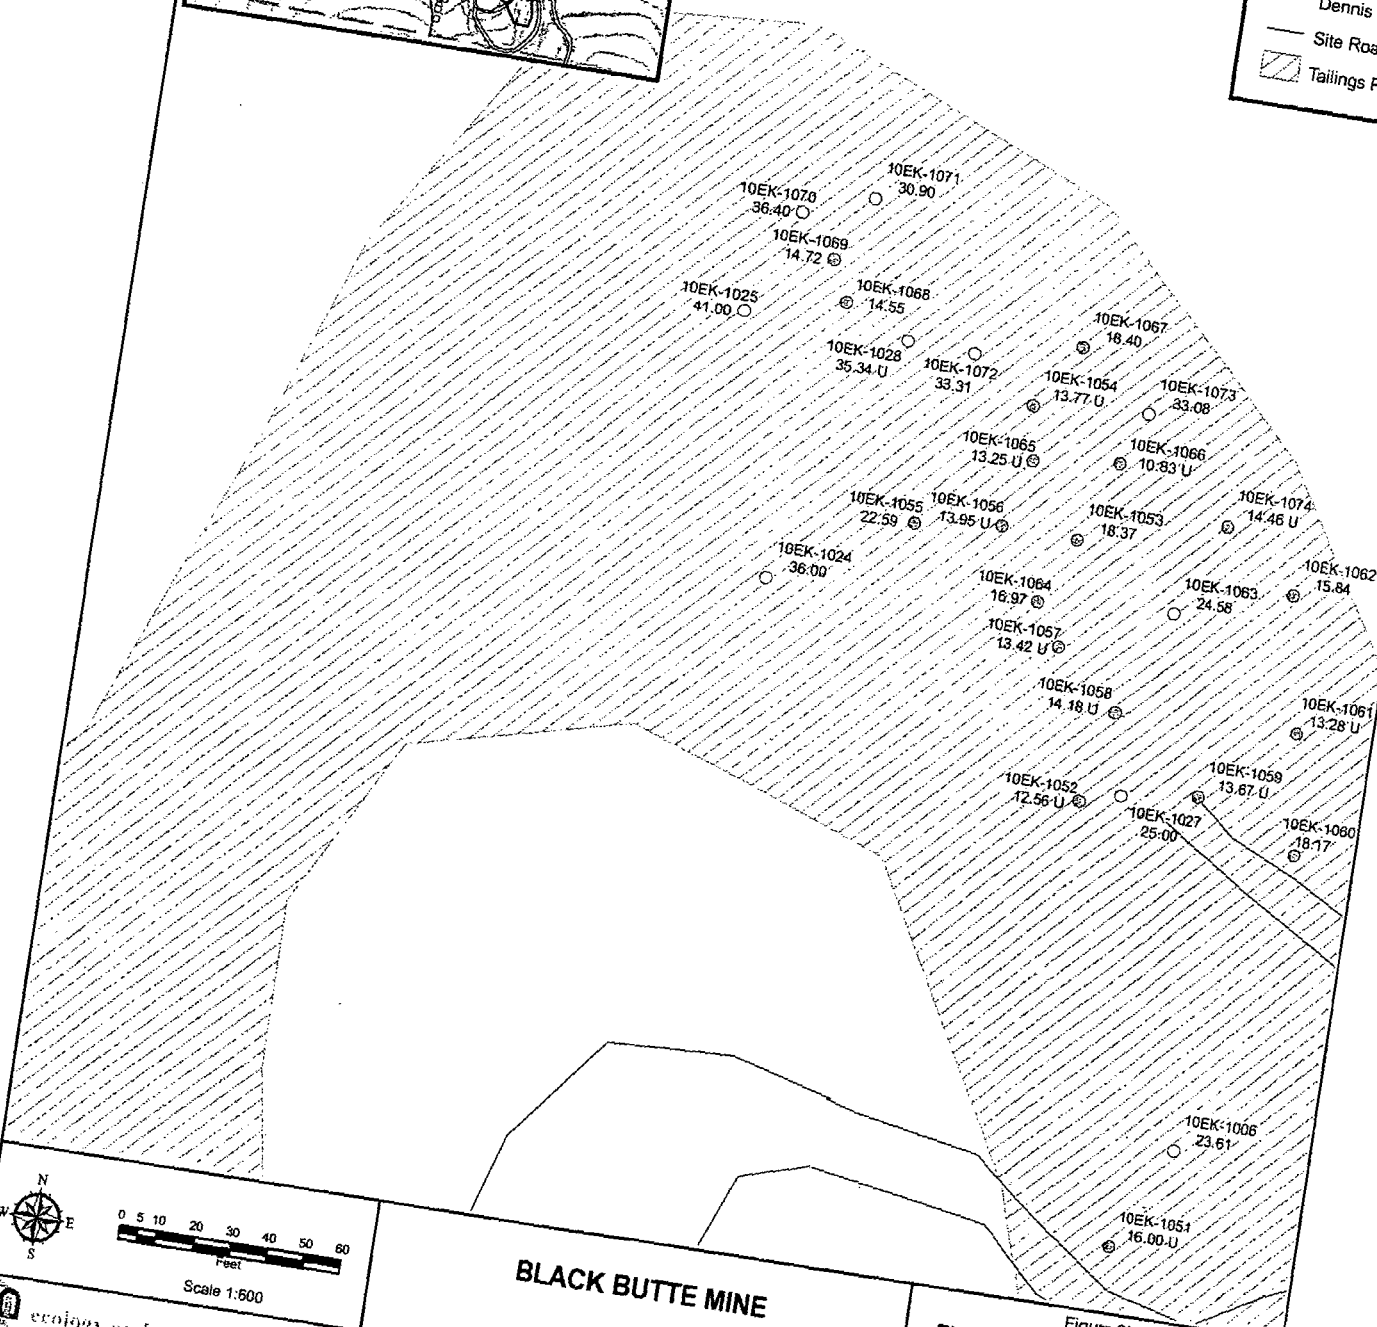
**Figure 2L**  
**Field Mercury Concentrations**  
**West Main Tailings Pile**

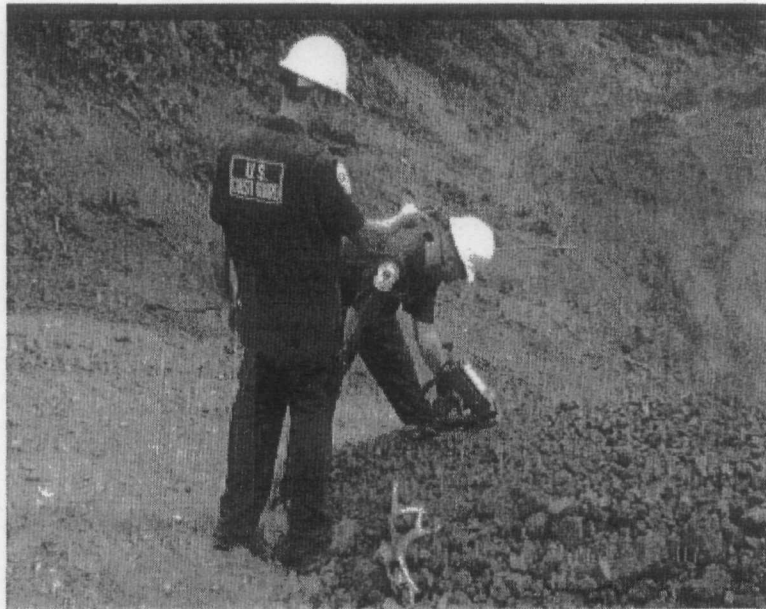
Photo 1 XRF testing of mercury in tailings removed from Main Tailings Pile - West slope.

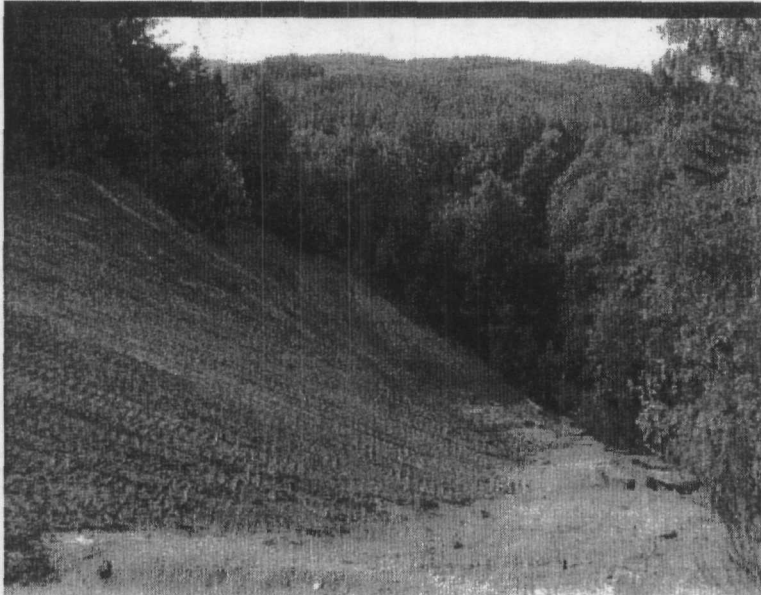
Photo 5 Main Tailing Pile - West slope with soil cap.

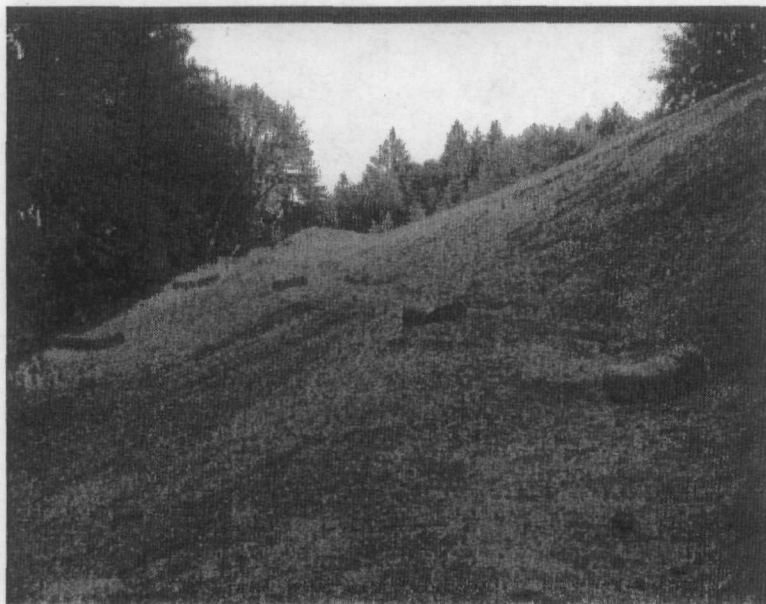
Photo 8 Straw bales placed on Main Tailings Pile - West slope.

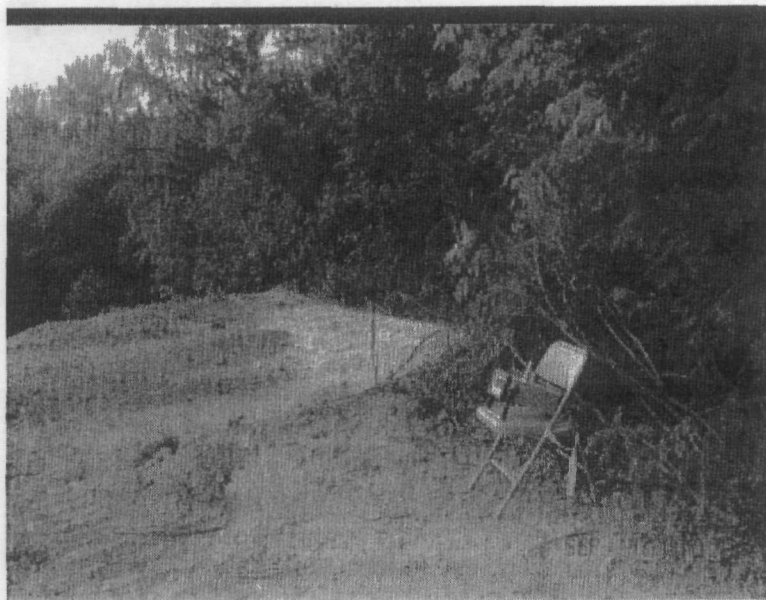
Photo 10 Dataram monitoring air at top of Main Tailings Pile - West slope.

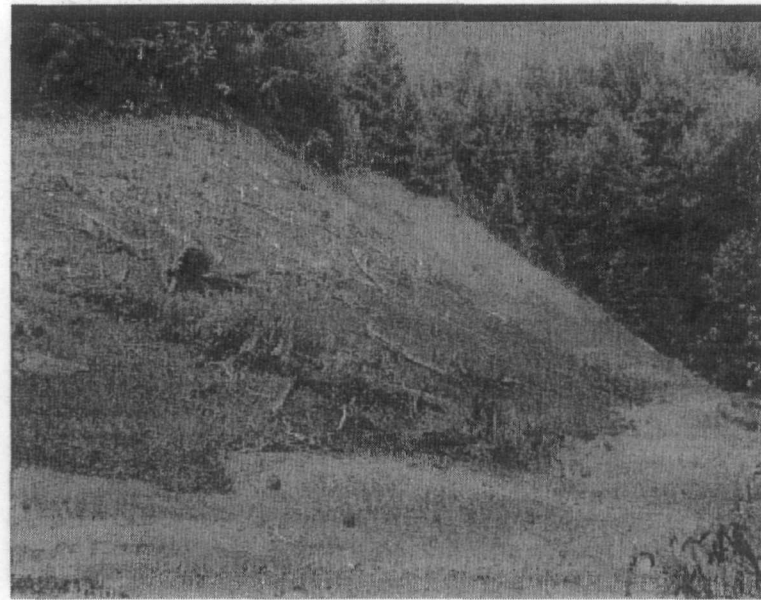
Photo 11 Main Tailing Pile - West slope showing soil cap with woody debris on surface.

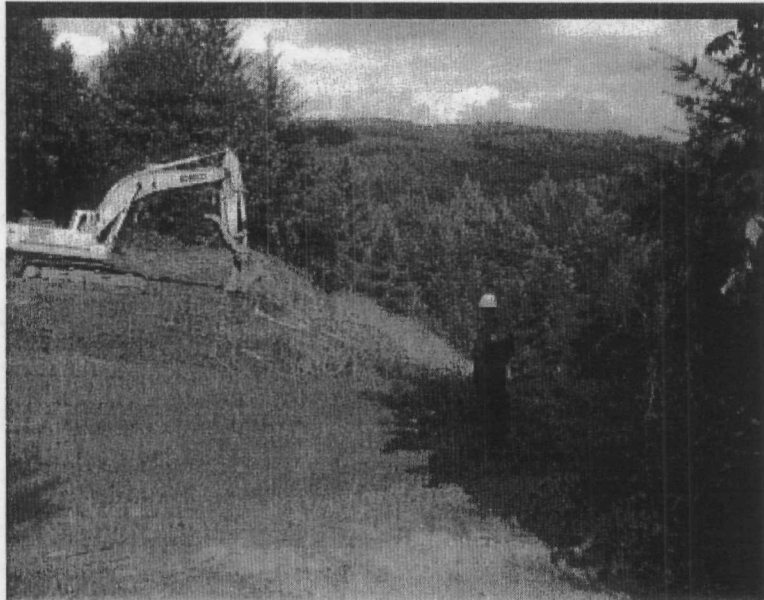
Photo 12 Main Tailing Pile - West slope showing soil cap with woody debris on surface .

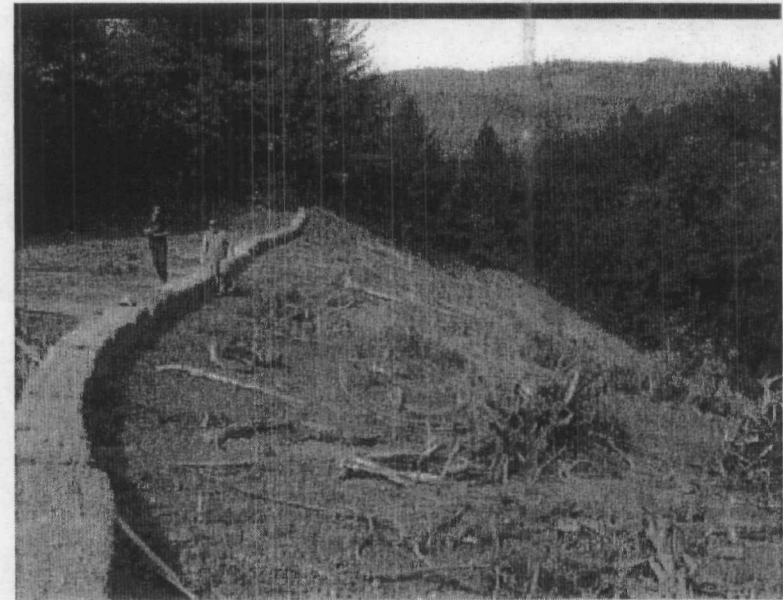
Photo 13 Main Tailings Pile - West slope showing woody debris placed on surface.

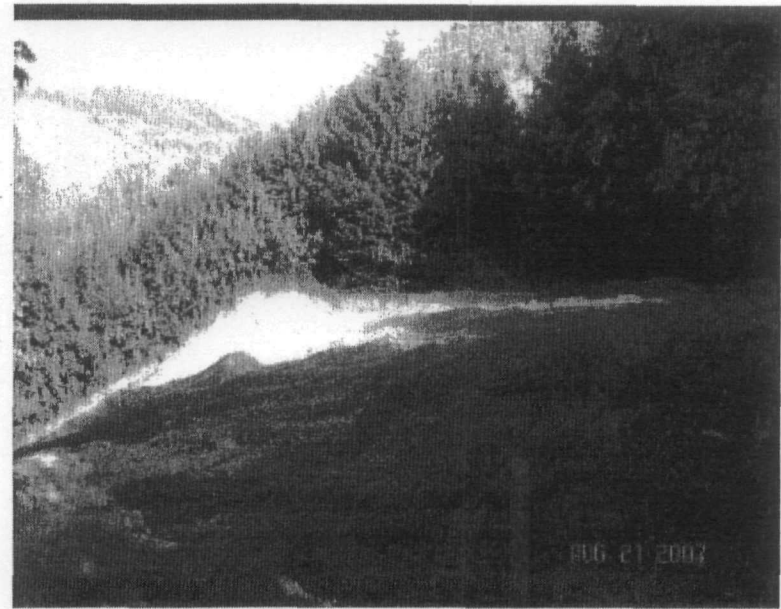
Photo 15 Main Tailings Pile - Starting to clear East slope.

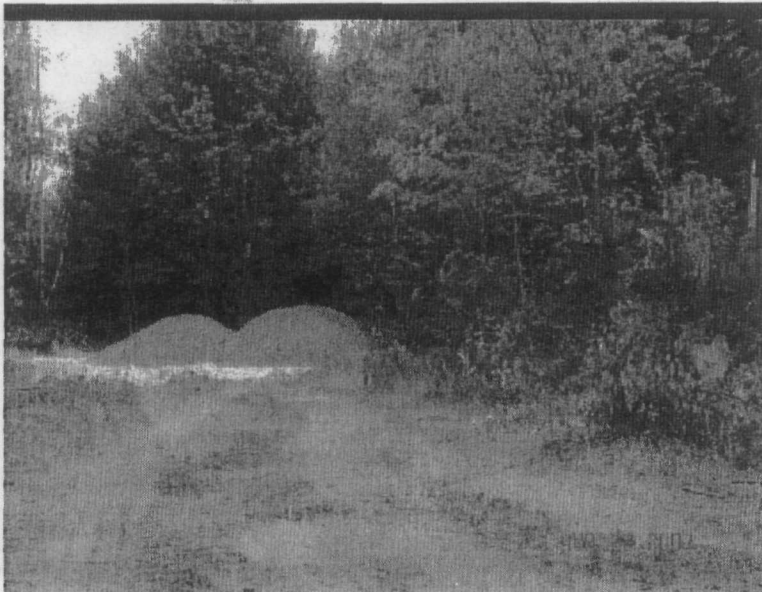
Photo 16 Moving tailings from Main Tailings Piles to New Furnace Area for capping.

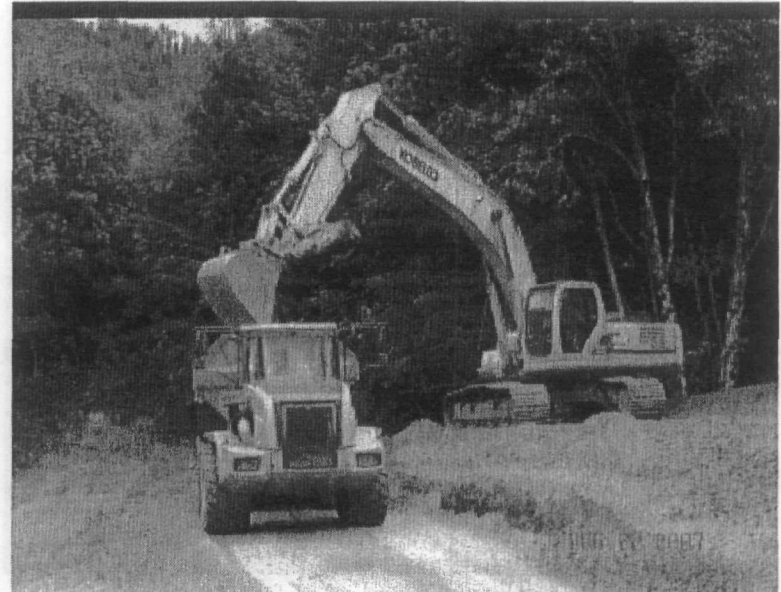
Photo 17 Main Tailings Pile - East slope tailings removal.

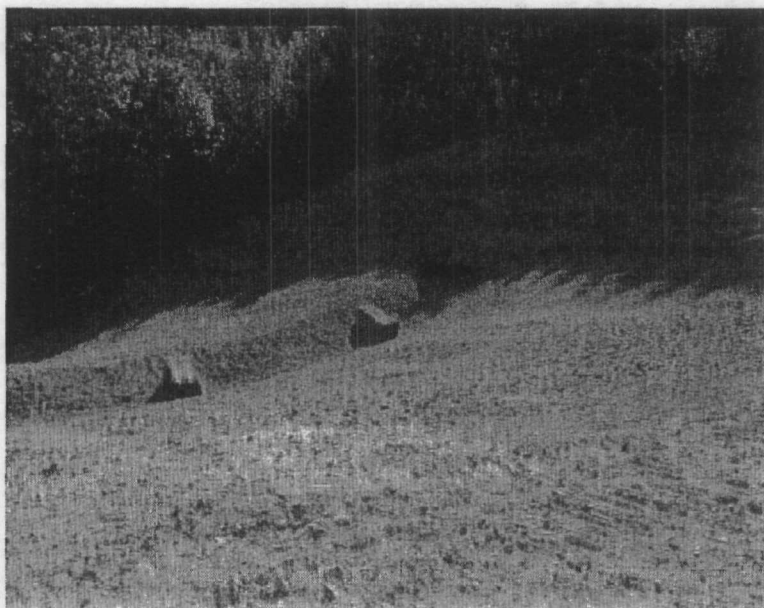
Photo 20 Main Tailings Pile - East slope prior to topsoil and hydroseed.

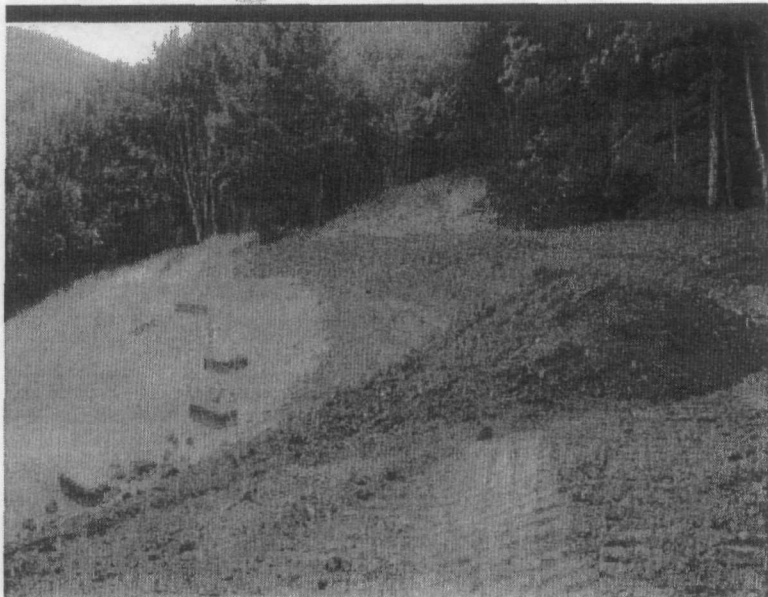
Photo 24 Clean cover soil placed on Main Tailings Pile - East slope.

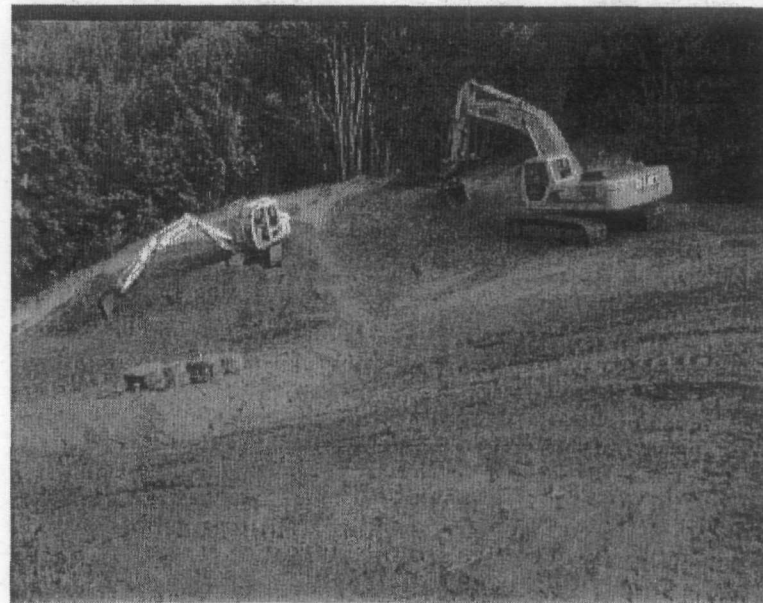
Photo 23 Main Tailings Pile - East slope adding soil cap.

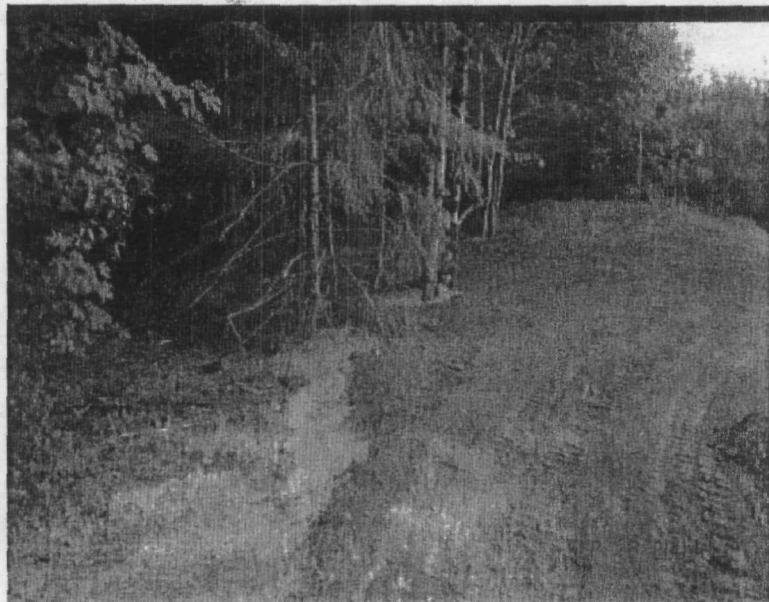
Photo 26 Clean soil placed on top of Main Tailings Pile - East slope.

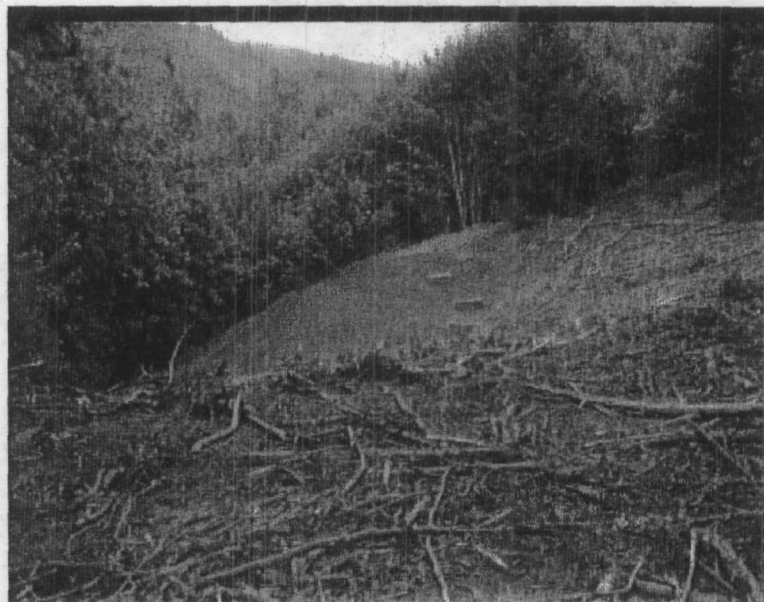
Photo 27 Woody debris placed on final slope of Main Tailings Pile - East slope.

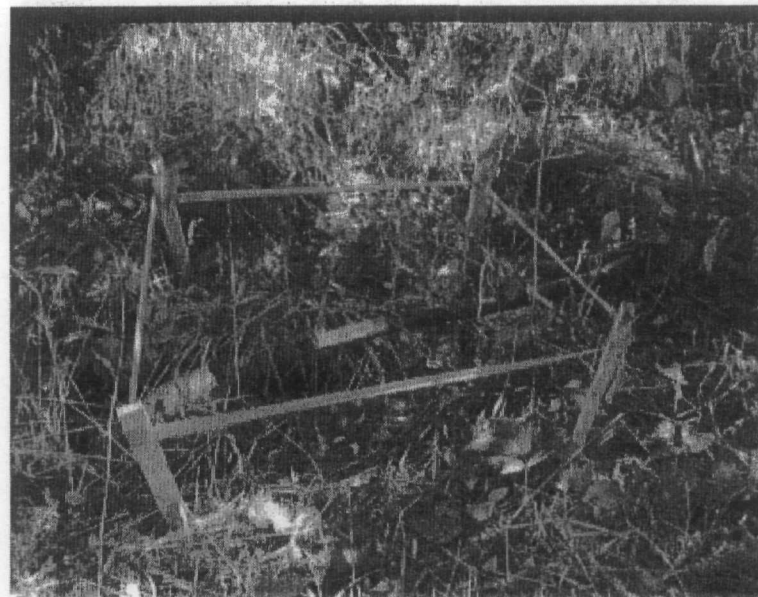
Photo 31 High visibility flagging around residential water line.
